## Altitude Bearing Mods on the 30 by Jim Fitch

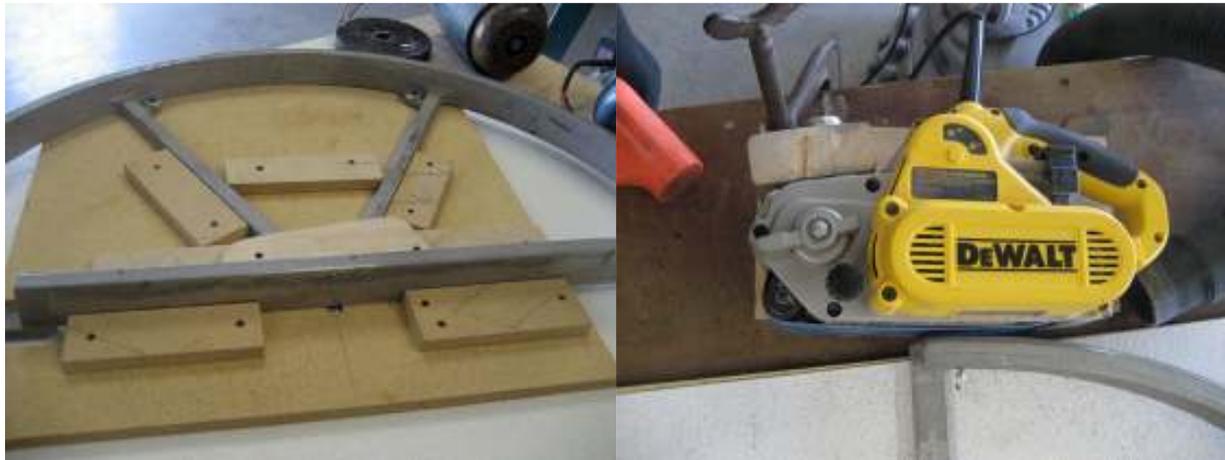
The photo on the left shows the jig that held the bearing. You can see the pivot bolt recessed in the jig. This pivot determines the center of the radius of curvature of the bearing. I took some time to position the bearing in the jig as precisely as possible.

The bottom of the jig has Teflon feet. The Teflon feet slide on a piece of glass-board, just like a rocker box and ground board work in a Dob. The belt sander can be seen in the right photo. It also has a pivot bolt. A "C" clamp is used to secure it at each new location as its pivoted against the bearing.

I would set the belt-sander to touch a high spot on the bearing, lock the sander on at high speed, manually rotate the bearing past the sander several times. Then adjust the sander a little tighter against the bearing, lock it down and rotate the bearing across the sander again. This process was continued until I had a uniform radius of curvature.

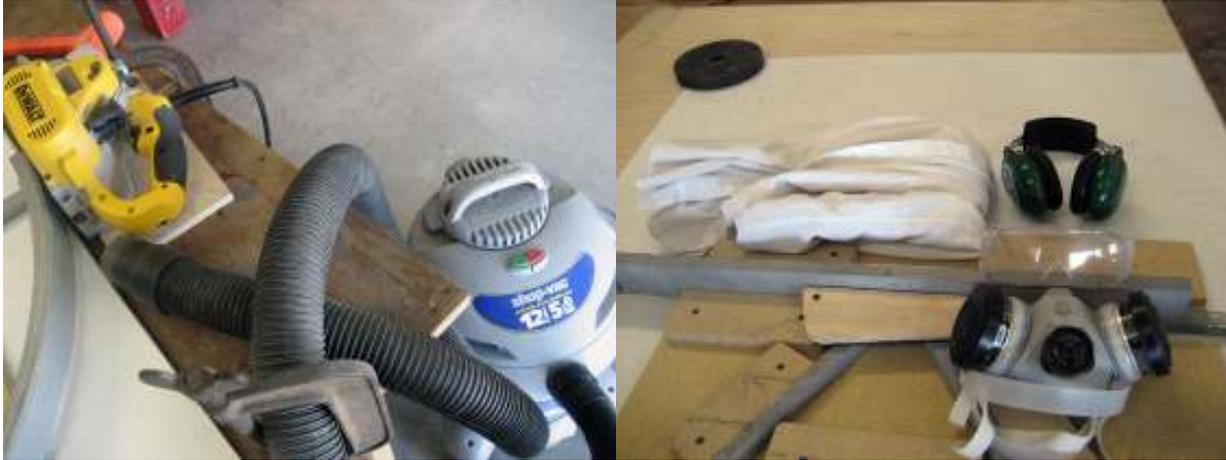
Both bearings were warped. Fortunately the warp in the second bearing was removed at the same time its radius of curvature matched the first bearing's radius. I now had a matched set. One concern I had was all the dust this was going to create. I opened all the shop doors, but I still didn't want to breathe all that dust. I set up a shop vac with the nose near the contact point between the belt-sander and the bearing. I also wore a respirator, hearing protection, safety glasses, and a couple of long sleeved shirts and gloves. The photos below show the dust control and safety equipment.

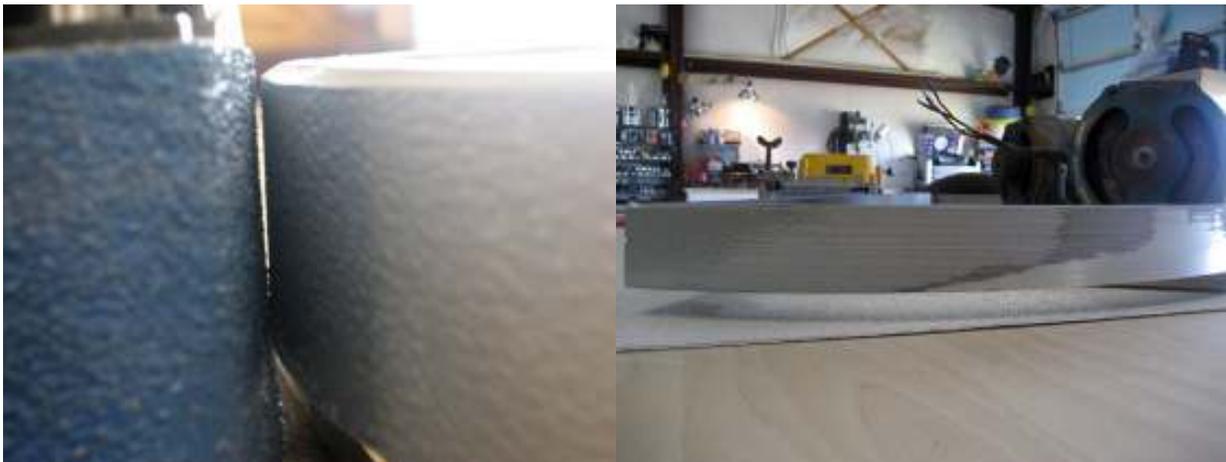
I knew that truing the bearing surface would involve sanding through the “relief angle” that is part of the sand casting processes. You can see this angle in the photo below on the left. The bottom of the bearing makes contact with the belt-sander while there is a gap between the two at the top. Removing this relief angle meant the whole surface had to be trued. There was no way to just remove the high spots.

The photo on the right shows how the sanding proceeded from the bottom to the top. You can also see that the bearing is not making contact evenly, as some places are sanded through to the aluminum while other areas are just beginning to make contact with the belt. In fact, the relief angle is already gone on one area to the right while the glass-board laminate has barely been touched on the area to the left.

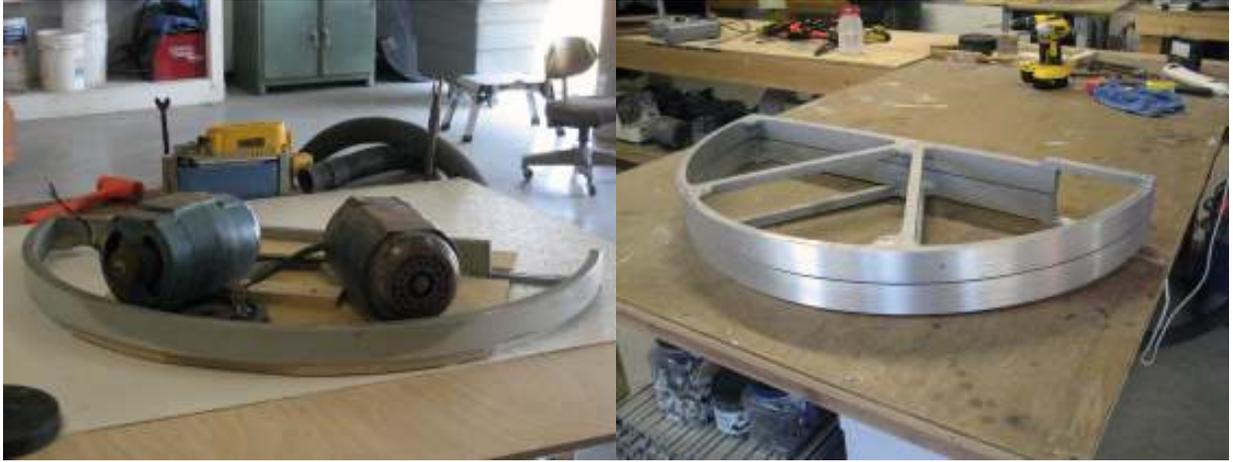
The photo on the right below shows the warp in the bearing. There are two areas of strong contact with an area of minimal contact between. In fact the two areas of contact are high spots with low spots on either side of each of them. The motors on the jig are being used as counter weights to make sure the jig does not tip or tilt. The bearing is rotated away from the belt-sander for the photo. In action it rotates against the blue belt.

The photo on the right shows what the bearings looked like after way too many hours on the jig. All shiny with a flat bearing surface and a matched, single radius of curvature.
